***United States Court of Appeals  
for the Second Circuit***

SEA-LAND SERVICE, INC., *et al.*,

AETNA INSURANCE COMPANY, *et al.*

**JOINT APPENDIX**

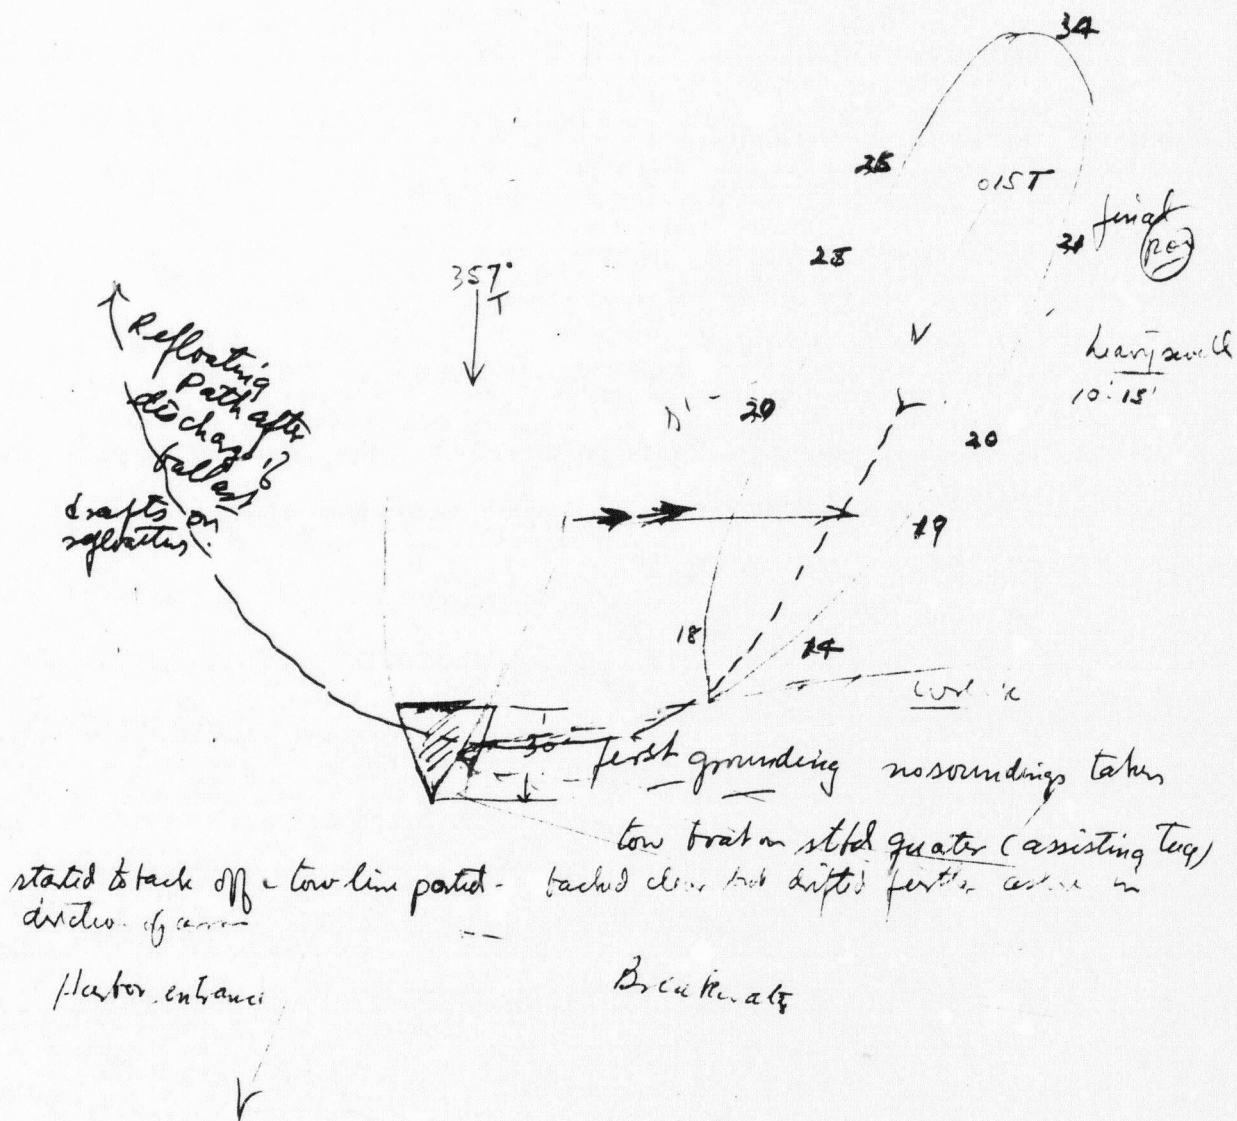
Plaintiffs' Exhibit 14

Soundings showed may 5.

deballasted forward & refloated bow,  
then ballasted bow & topped by  
bow - for final refloating

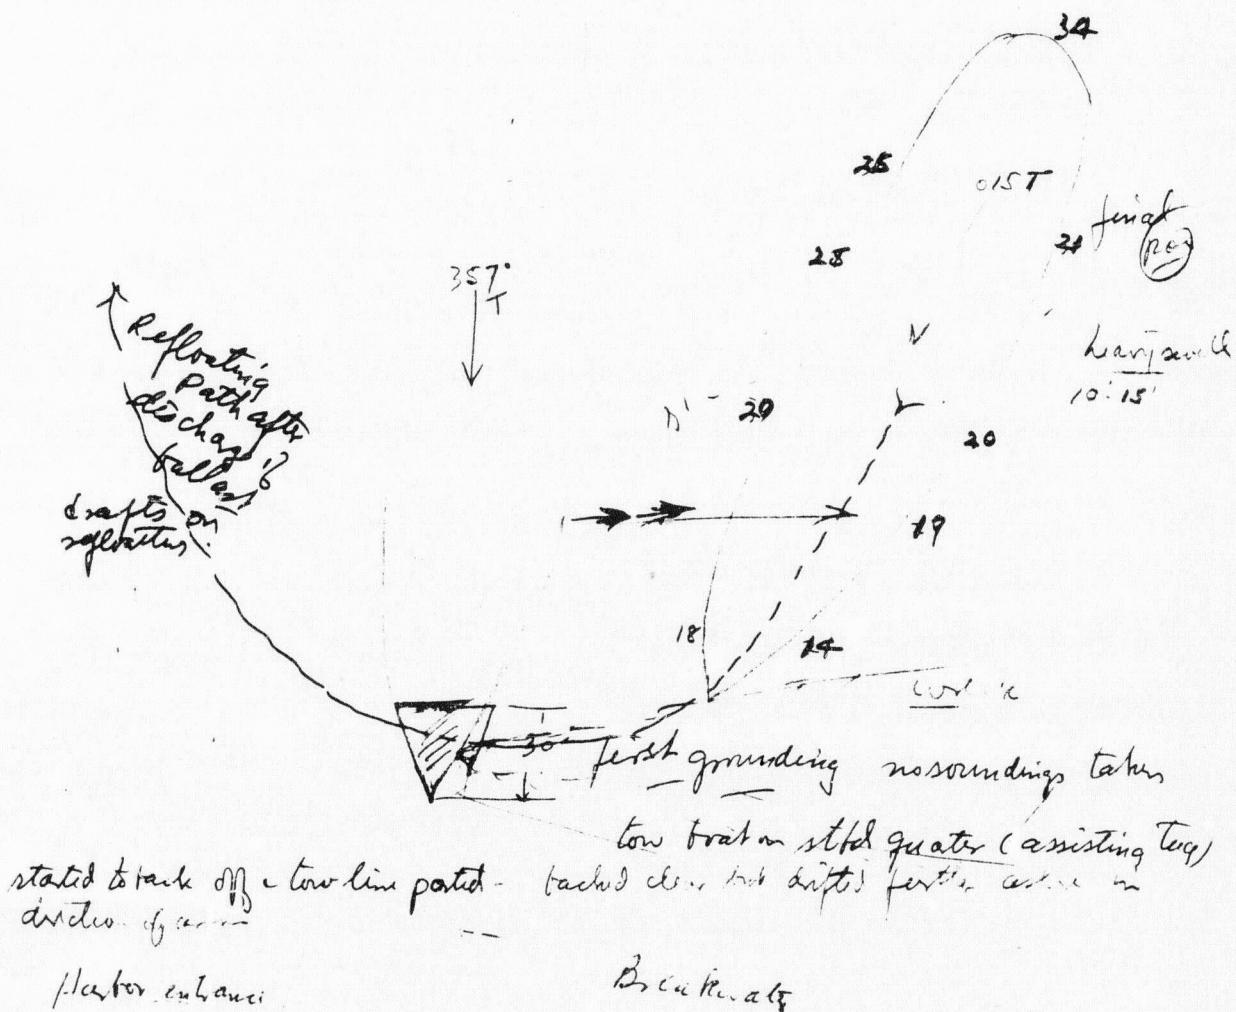
BEAUREGARD

Drafts  
F. 18'-4"  
A. 25'-0"  
Soundings showed May 5.

deballasted forward & refloated bow  
then ballasted bow & tipped by  
bow - for final refloating
